# New Vapes: Solutions for VOC Analysis

## Cerulean, Milton Keynes, UK

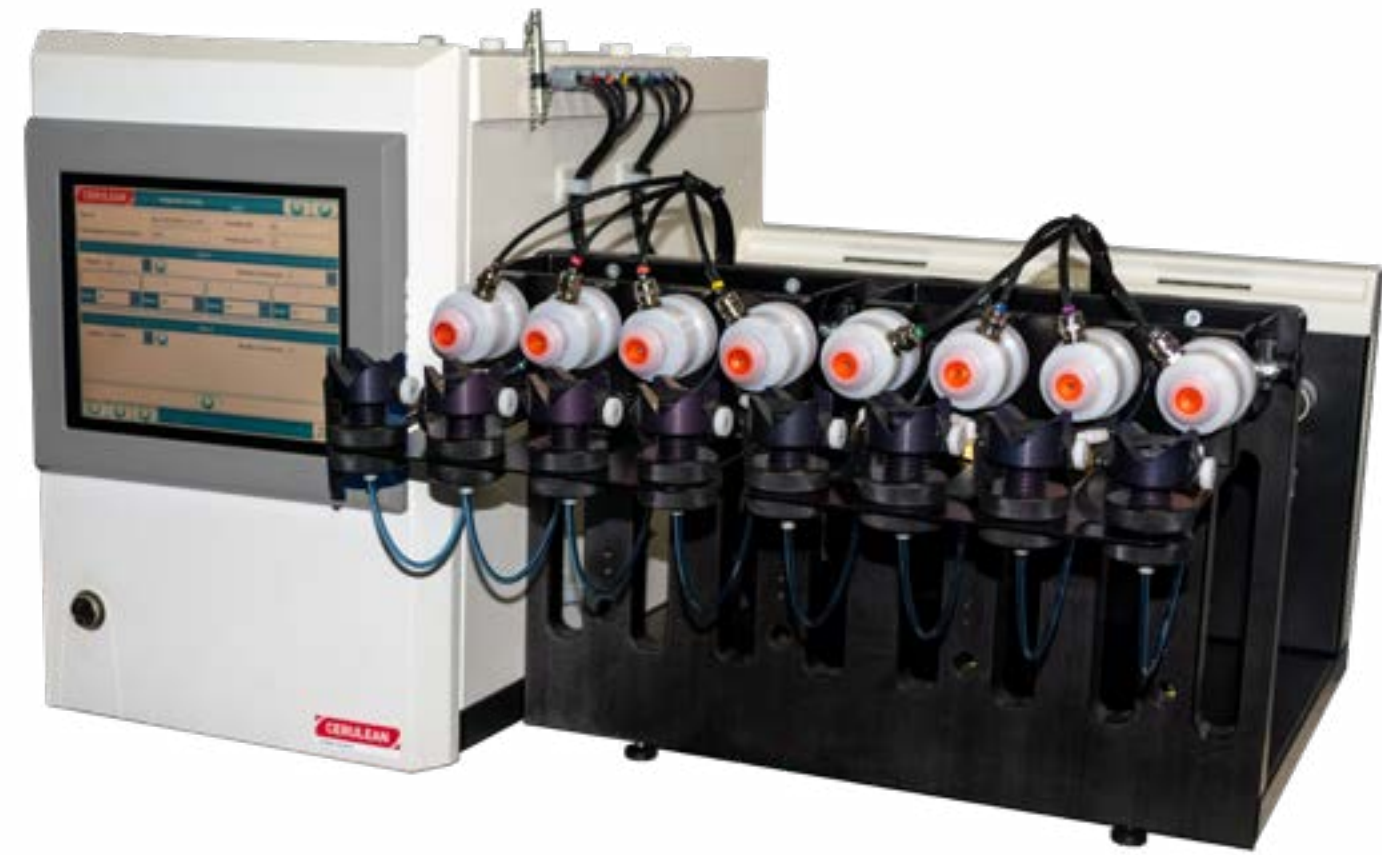
Figure 1: Cerulean CET8 8 port vaping machine fitted with End Point Detection system

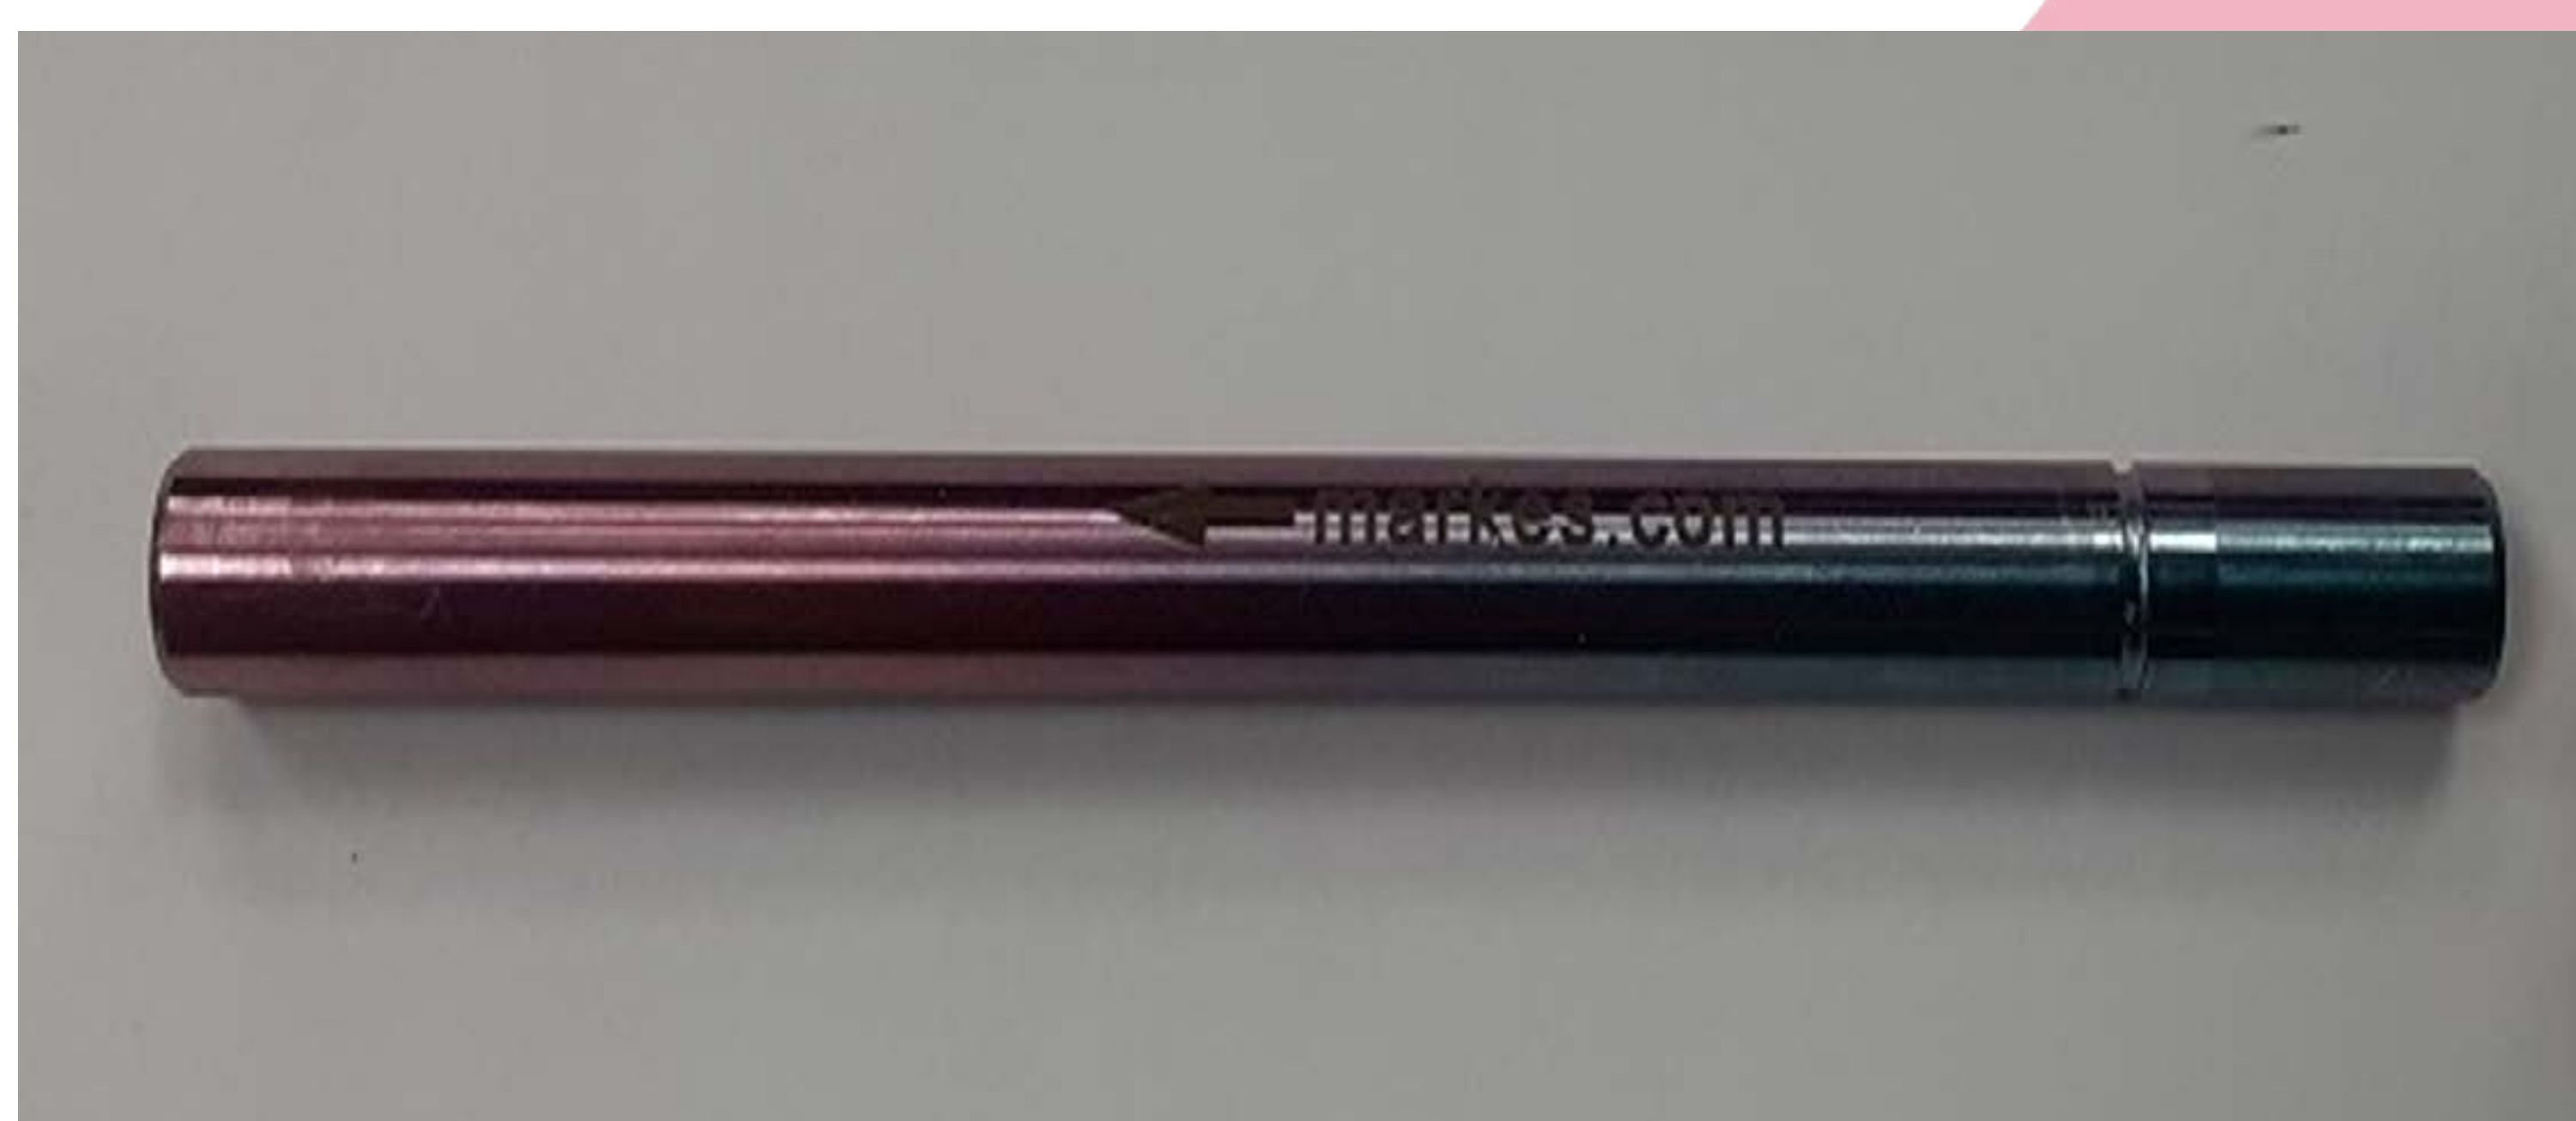
Figure 2: Markes sorption tube used in experiments

The sorption tube used was a Markes type C3-CAXXX5266 (Inert Universal). This was connected to the puffing port with thin walled silicon tube.

This was measured at approximately 1700mmWG (measured at a flow rate of 17.5ml/sec to ISO2965). Normally the pressure drop of an e-cigarette would be 100-200mmWG. However the CET18 can tolerate higher pressure drops before the engine stalls.

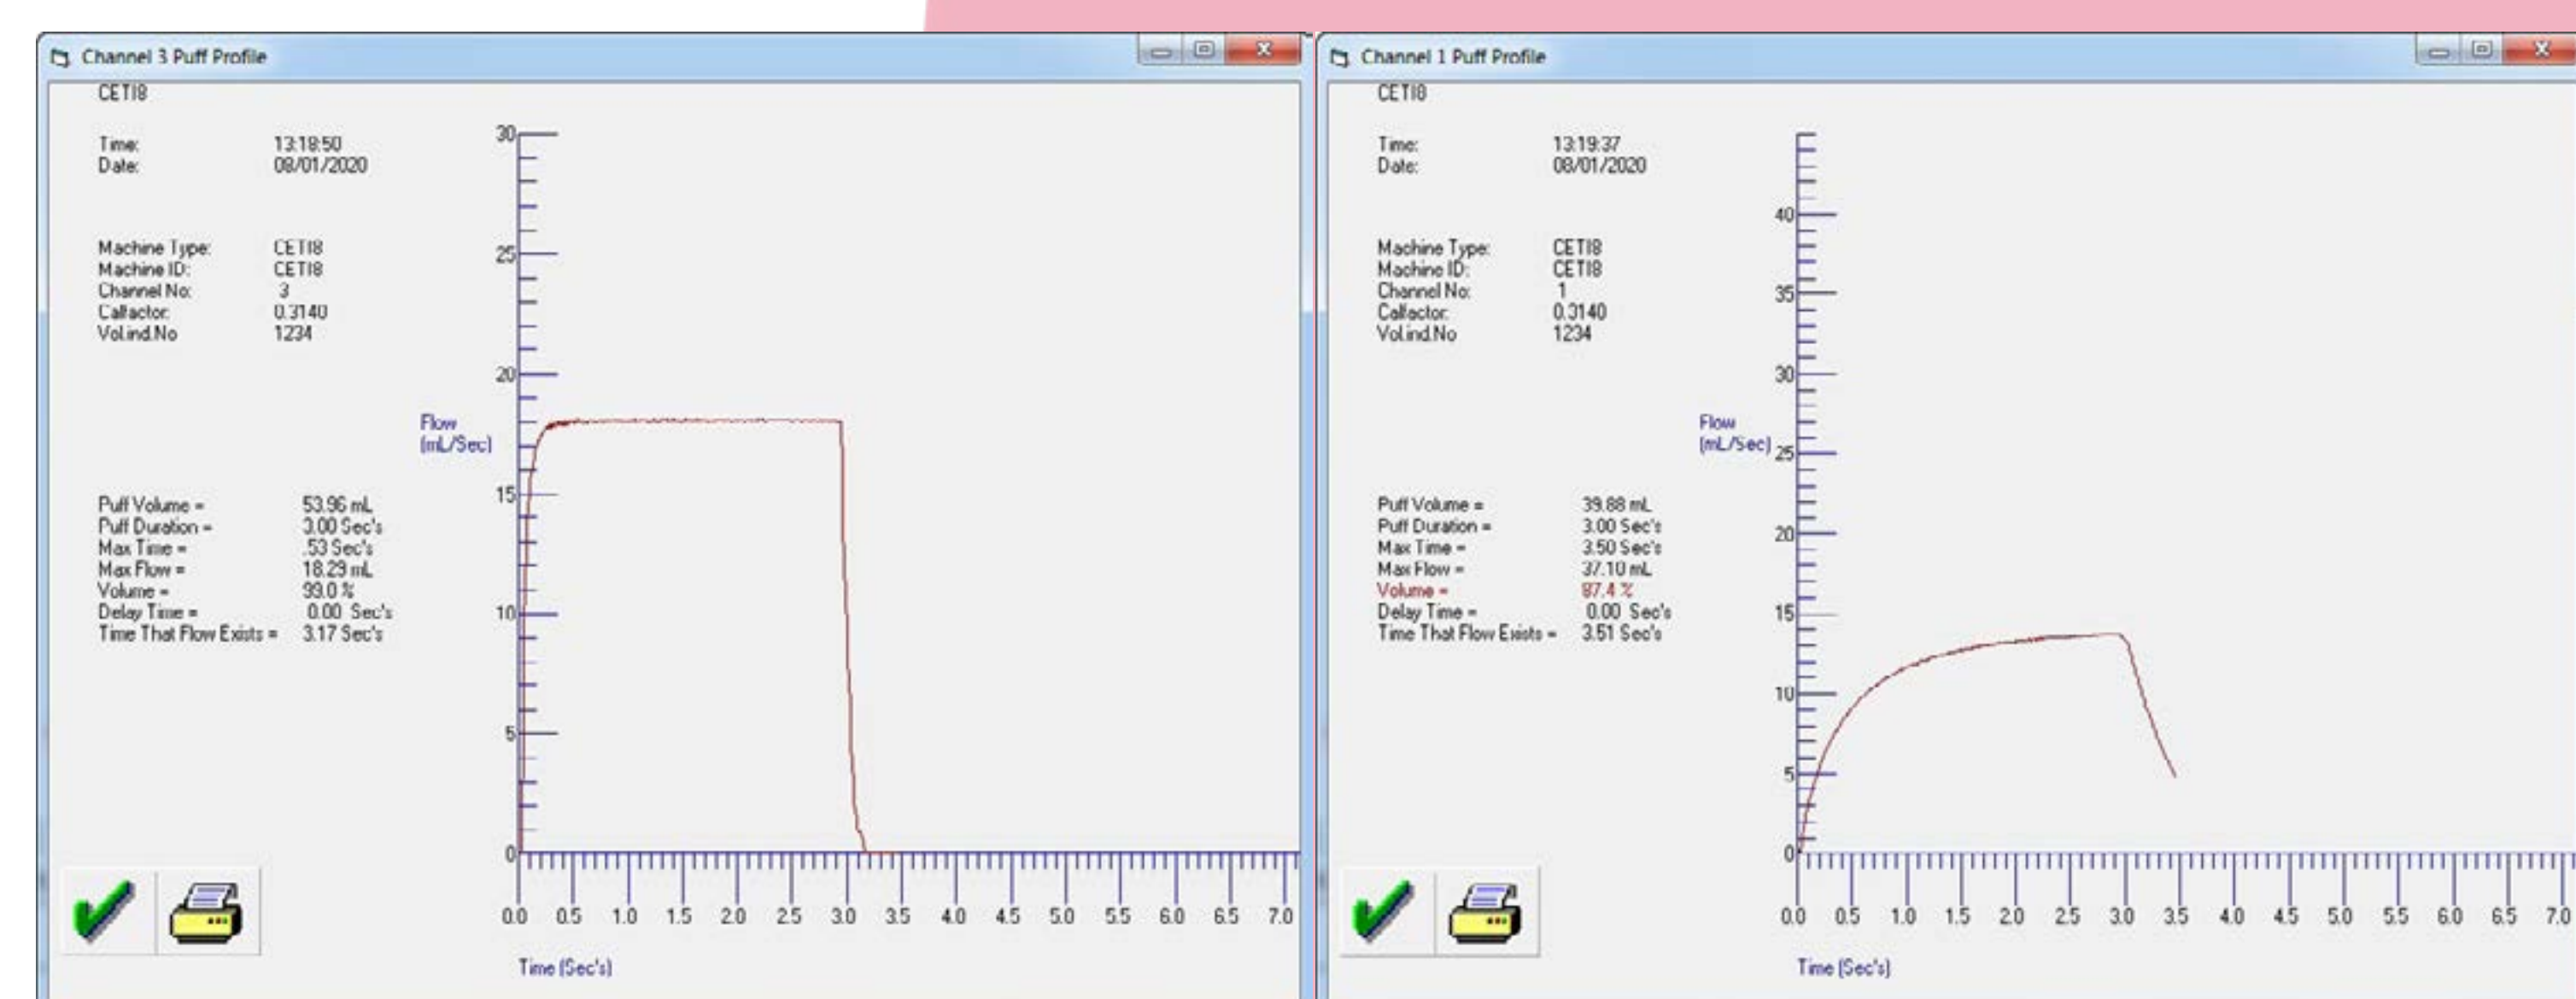
Figure 3: Visualisation of flow, time and swept volume of the CET18 with a 100mmWG pressure drop and Markes TD tube in series. Nominal volume 55ml, puff duration 3 seconds. Measurements made with Cerulean's VFA450RH.

The above plots show the fundamental problem of this high pressure drop device, flow rates are truncated and this can prevent the e-cigarette vaping correctly. The high pressure drop "smears" out the profile puffed. There is a significant lag in the puff drawn and the 55ml puff is truncated to a sub 40ml puff. The peak flow rate drops from 18ml/sec to 13ml/sec. This is caused by a partial vacuum being created in the tubing /Markes tube and the puff valve shutting off before all the air for the puff is drawn.

A comparison of the puff profile was made between a CET18 with Markes tube fitted and one with a more representative 100mmWG pressure drop in line.

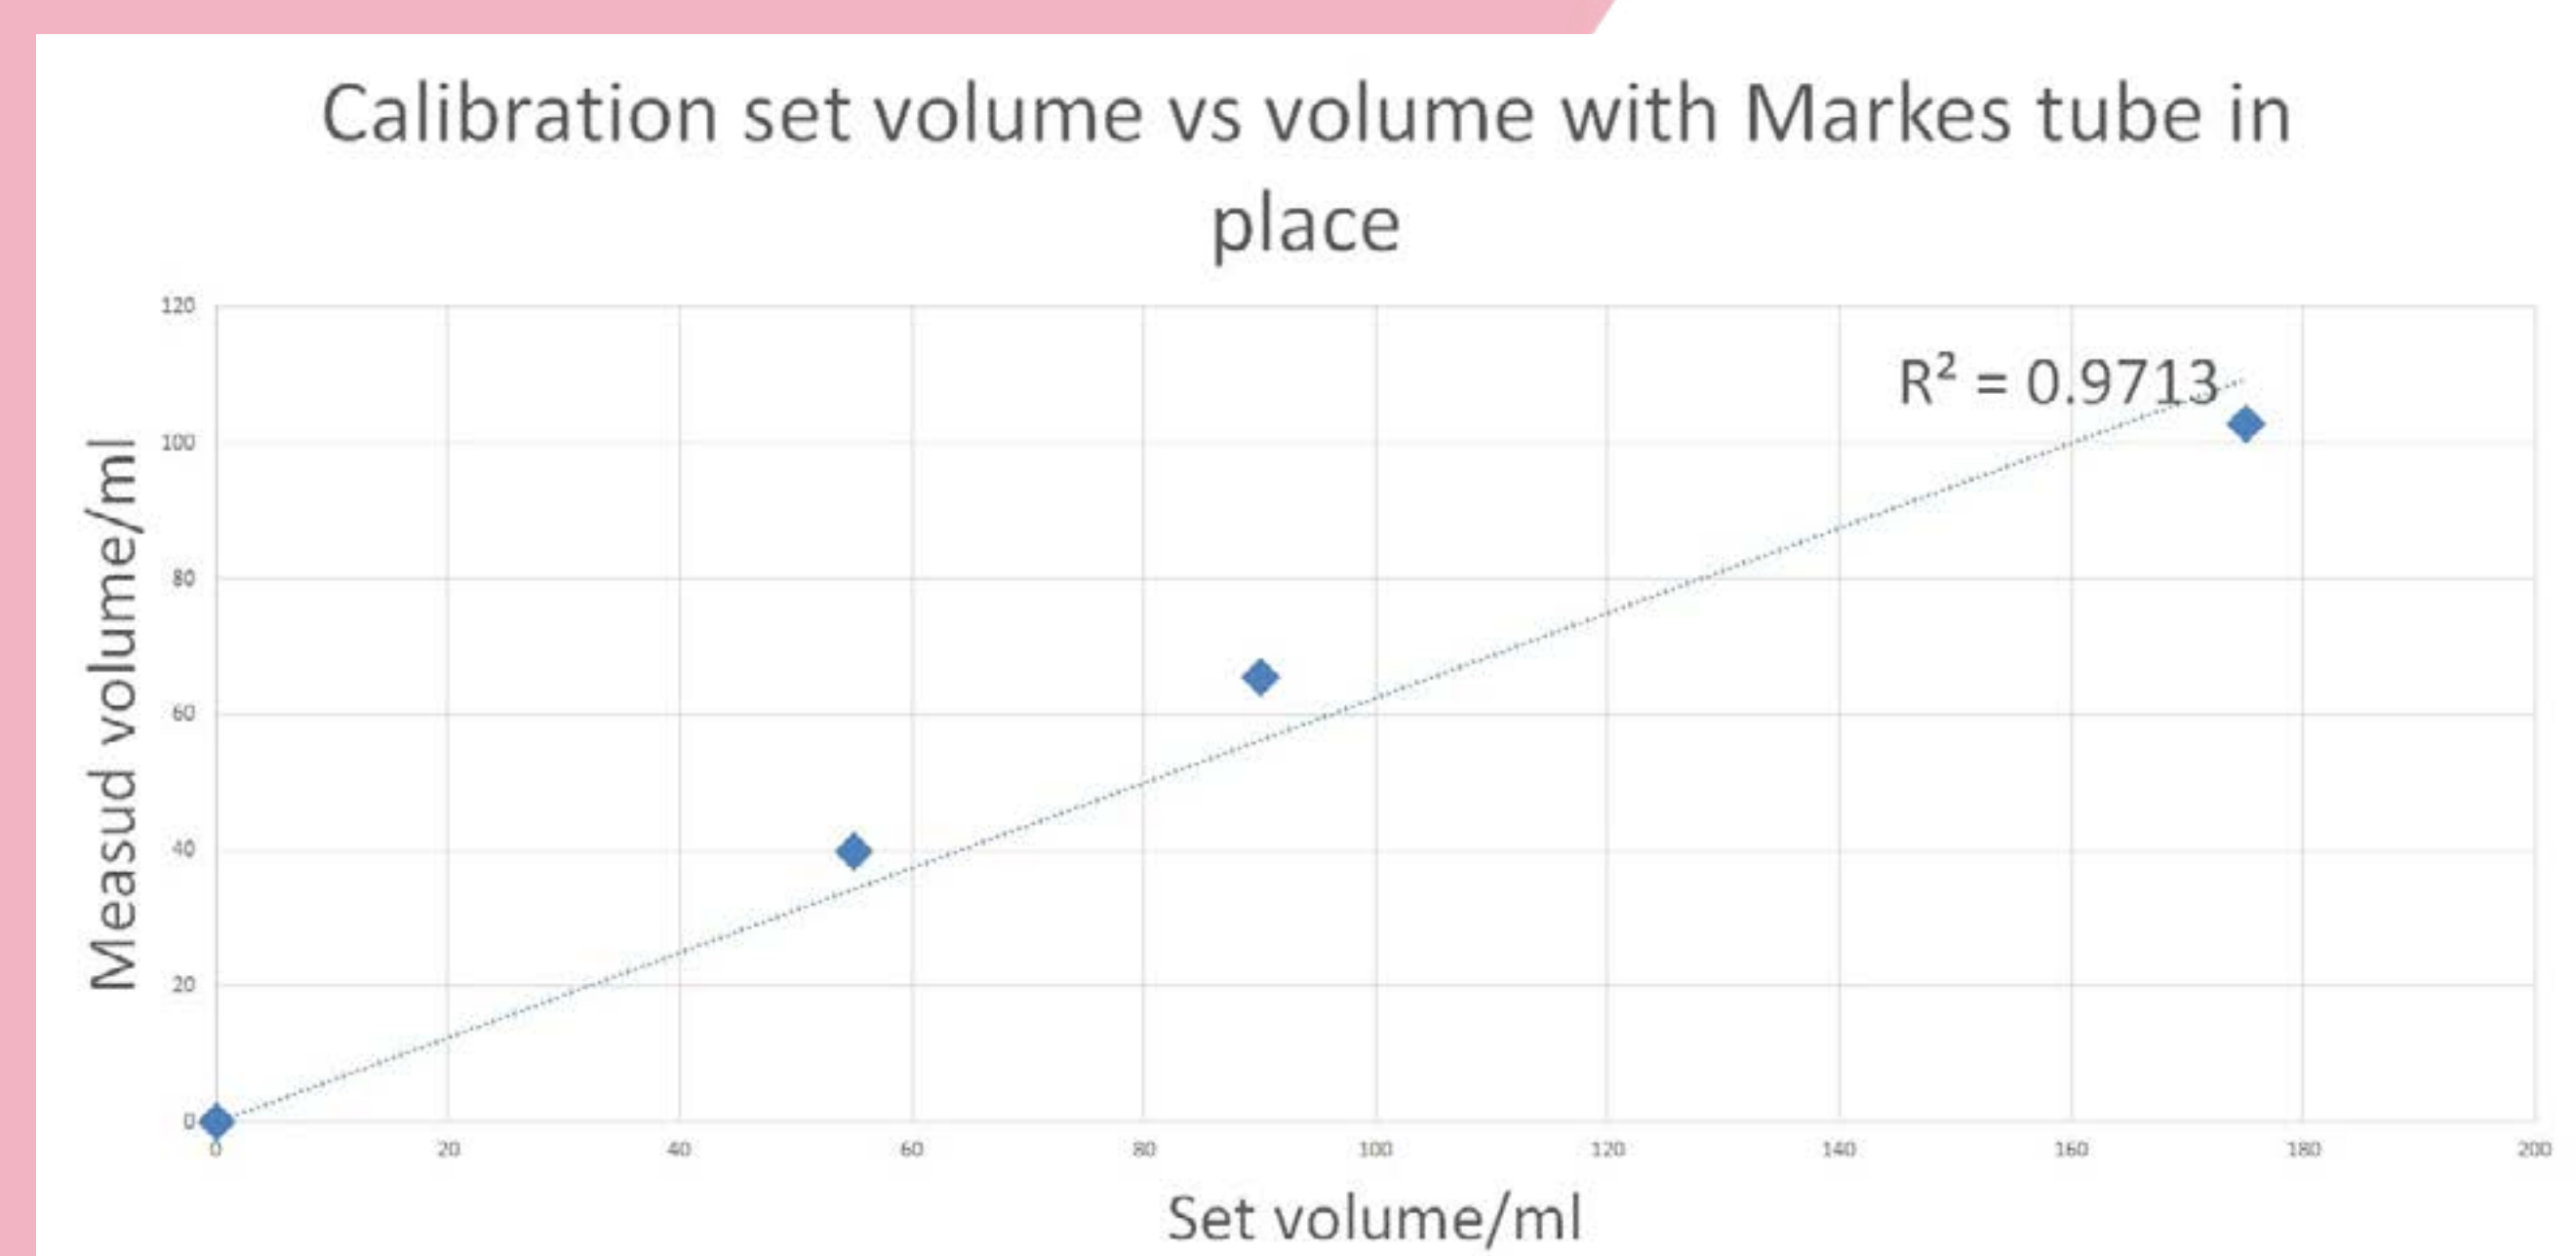
Firstly tubing was replaced with a more robust section to prevent tube collapse. Next the puff volume was modified to allow for the partial vacuum being created in the Markes tube. A simple calibration curve was created of set volume vs true volume (and peak flow rate). This allowed a volume of 55ml to be drawn through the Markes tube by setting the CET18 to an approximate 85ml volume.
